EXHIBIT B –  
Declaration of  
Amy Katherine Taylor

Case No. 6-22-cv-00028-NKM

**DECLARATION OF AMY KATHERINE TAYLOR**

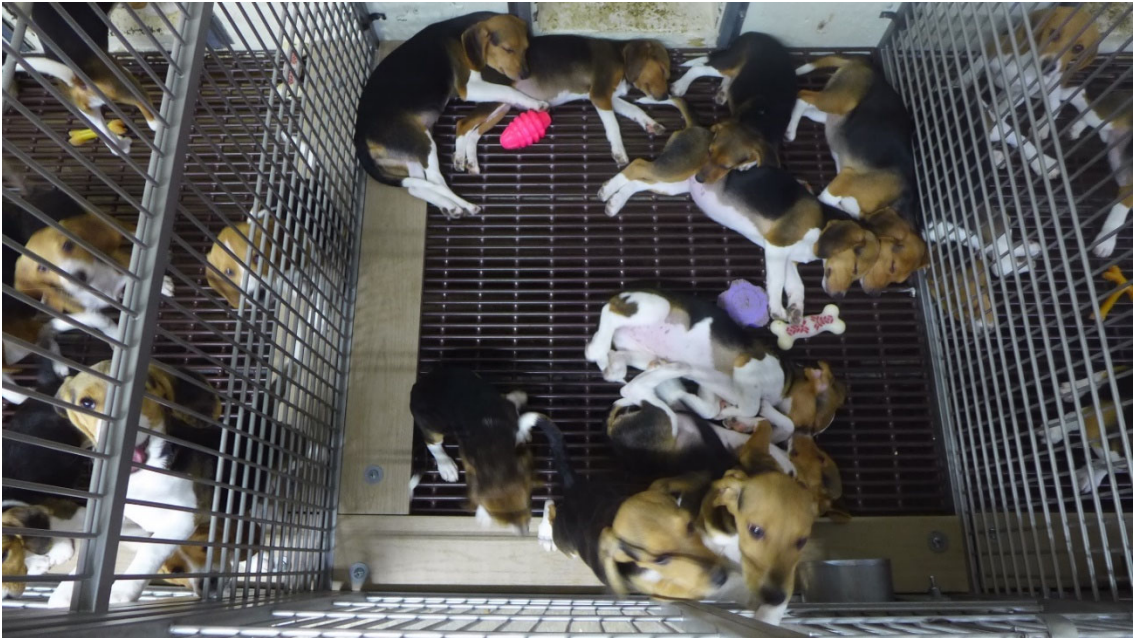
4. I observed that there were enclosures with numerous animals in them, and that there were enclosures that contained nine or more dogs. *See photo below.*

For example, enclosures 9A102, 9A103, 9A105, 9A106, and 9A107 all had 10 dogs in them, and enclosures 9A124, 10A16, 10A23, 10A24, and 10A25 had 9 dogs in them. In many enclosures, I observed that one beagle would be hunched in the corner in a manner that indicated it was overwhelmed.

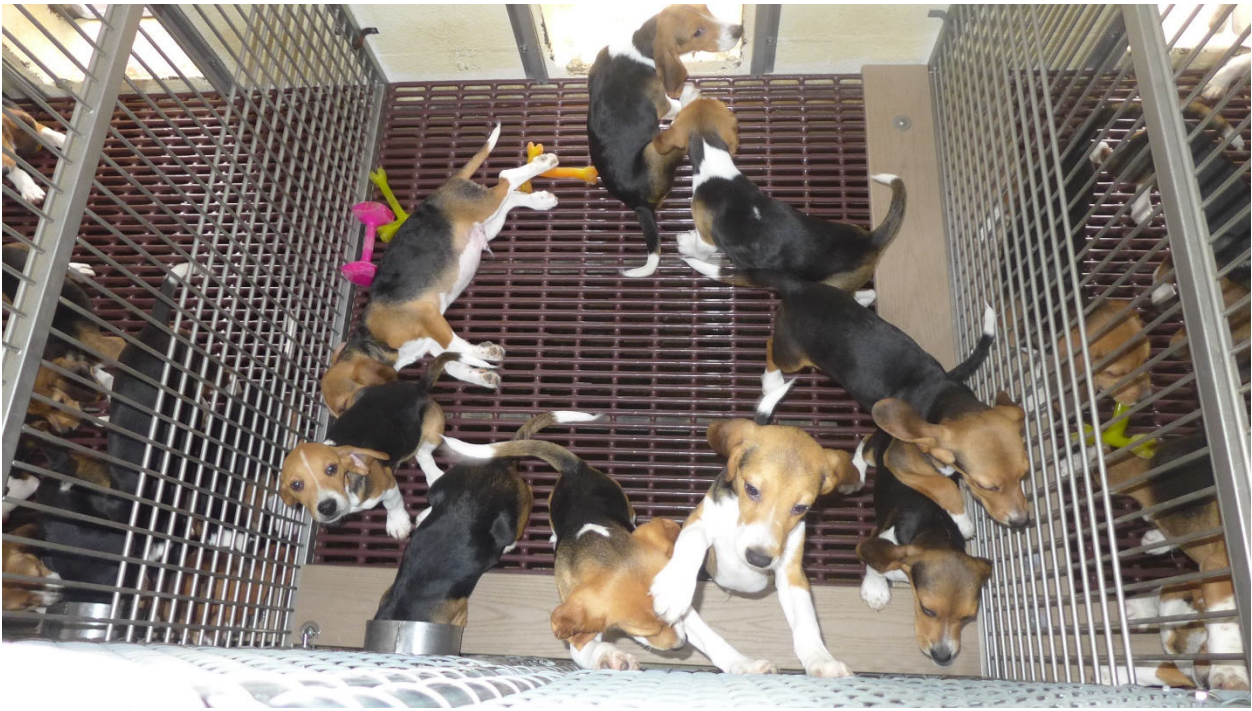
7. Each enclosure only had one food receptacle, which allowed only one dog to access the food at a time. *See photo* (The feeder is at the bottom left corner of the enclosure at the bottom of the page. The photo shows one beagle eating from the feeder.). I saw multiple beagles exhibiting behavior indicative of resource guarding in front of the feeders.

For example, I observed dogs laying in front of the feeder with their head in the feeder and, when another beagle would approach the feeder to attempt to eat, the dominant beagle would start to growl.

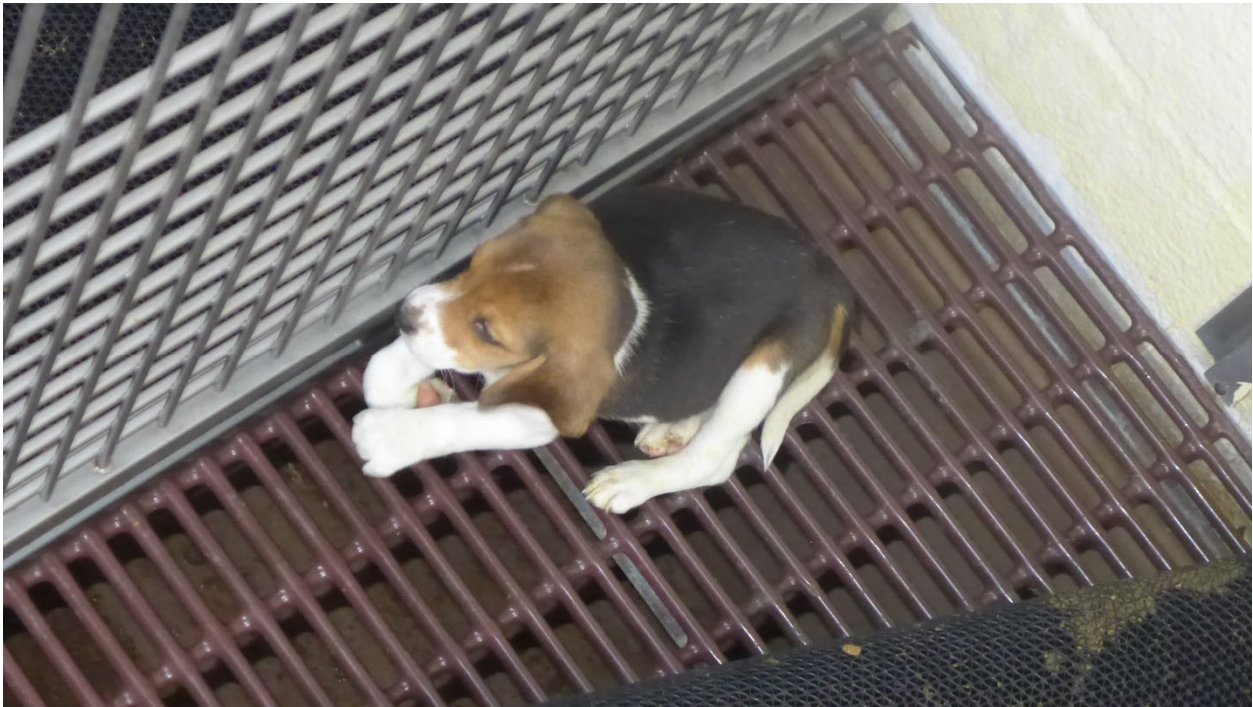
14. The flooring in the enclosures were made of grates, and allowed for the feet and toes of the beagles to slip in through the grates. The building that contained the nursing mothers and their babies contained black rubber mats on top of the grated flooring, and in more than 12 separate enclosures I saw that the black mat had shifted and moved in a way that exposed the grated flooring underneath. *See photo.*

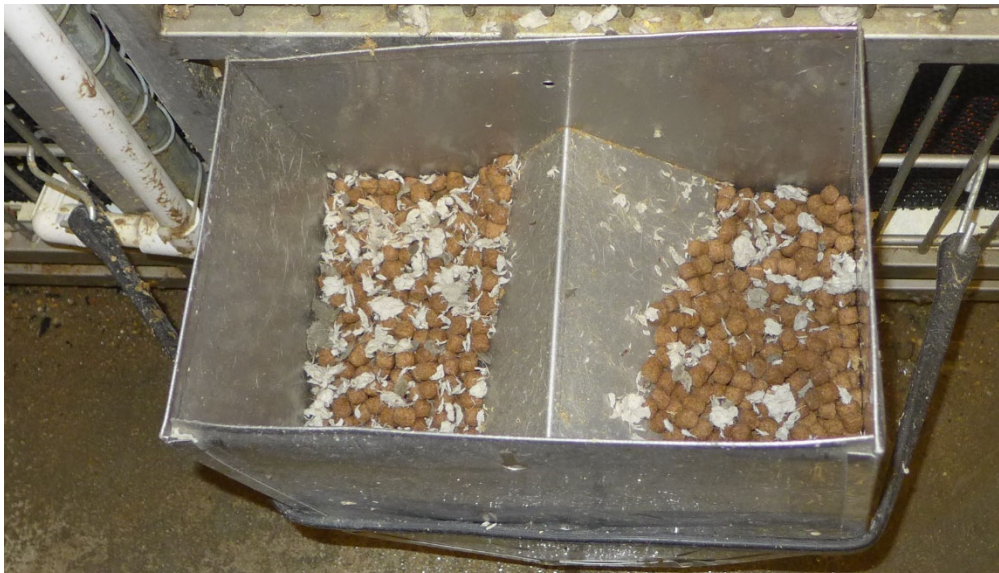
19. I saw that food was underneath the food receptacles, and observed bugs crawling and flying out of the moldy food. In the whelping building with nursing mothers and puppies, some food receptacles had no lids. I observed that the food inside the food receptacles had

moisture, filth, bugs, hair, dirt, and feces in it. *See* photo above. I personally found two neonate puppies inside of the food receptacles, which is dangerous to the neonates because they could get trapped in the feeders and dangerous for the nursing mothers if the food becomes contaminated by feces from the neonate.

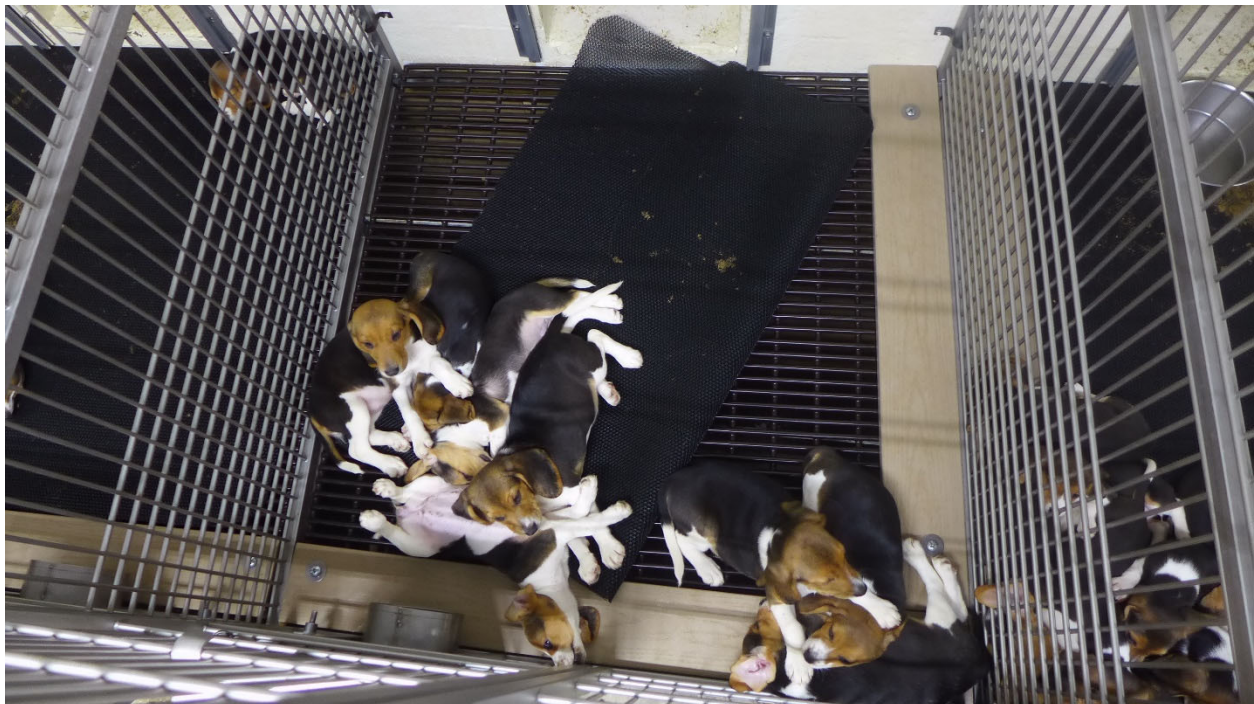
20. I observed employees cleaning the enclosures. While the employees were powerwashing the enclosures, I observed that the dirty water was splashing into the feeders. I noticed that, after employees went through the building to power wash the enclosures, no employees went through the building to spot clean the enclosures. In the building housing nursing mothers and their puppies, I saw that employees would power wash the enclosures but would only wash the top side of the black rubber mats that were on top of the flooring. I did not see the employees ever remove the rubber mat to clean the other side of the mat or the grated flooring underneath. After the powerwashing was complete, I observed that the rubber mats still had dirt, grime, and feces on them. In addition, I observed the mats folded over by the dogs exposing the underside of the mats. *See* photo below.

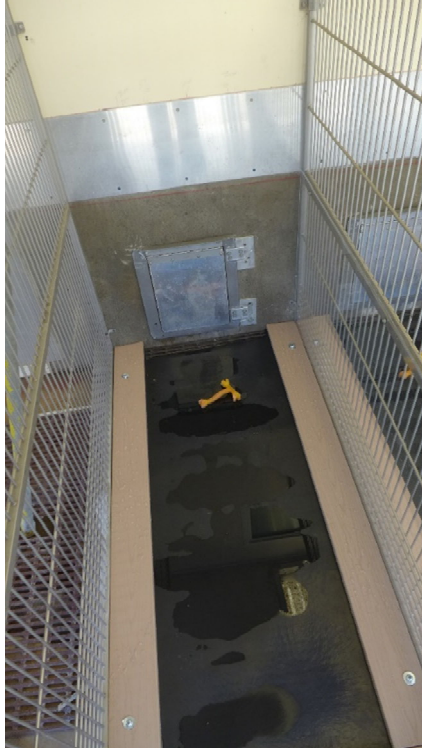
28. I observed that some enclosures had new black mats installed on top of the grated flooring in the enclosures, and that these black mats were installed in both the indoor and outdoor portions of the enclosures. The mats are not porous and, thus, allow liquid as well as urine and feces to pool so that the beagles were forced to stand, sleep, or lie in their own excreta. *See photo below (liquid pooled on top of the mat).*

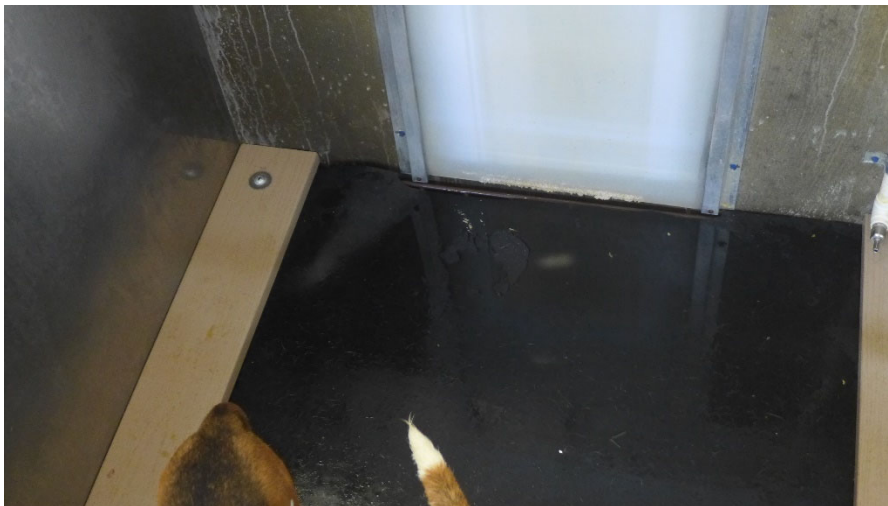
I personally observed that in some enclosures where the mats had been installed, beagles were standing in their own urine and feces. *See* photo below (beagle standing in urine).

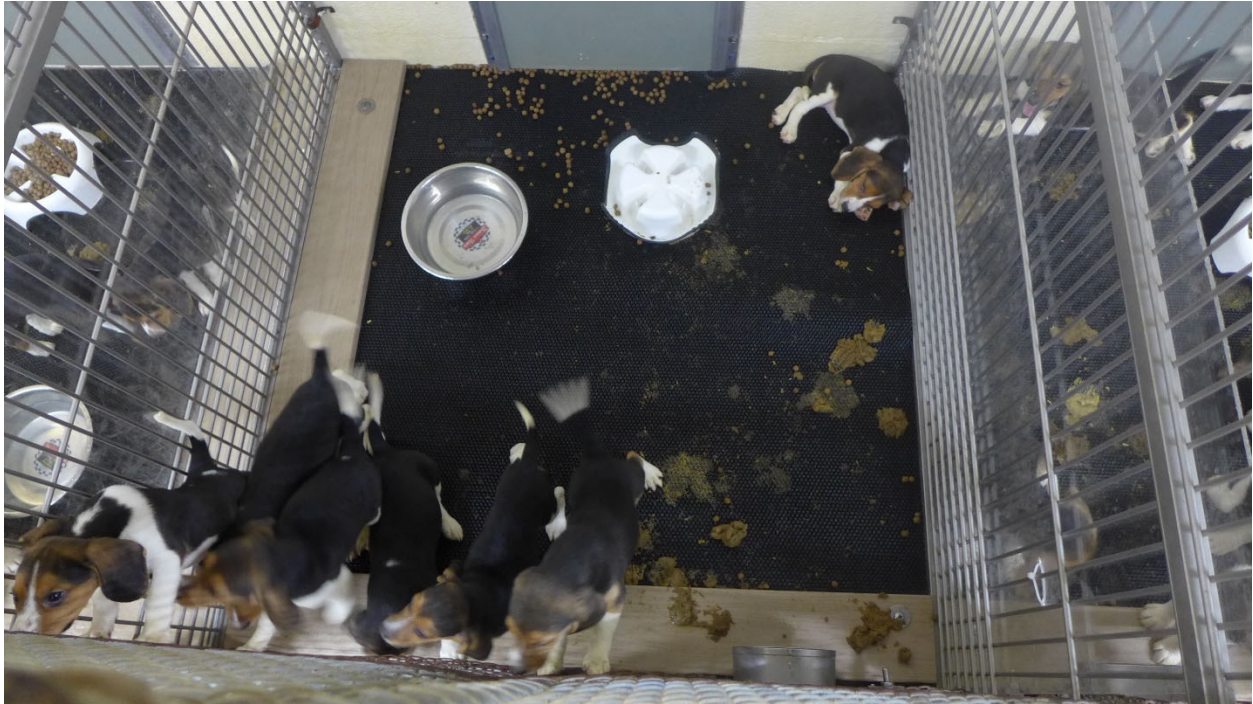
36. I also observed some enclosures that contained food bowls with kibble.

However, the food bowls could be turned over by the beagles, exposing the food to the feces on the mats. *See photo below.*
